**Flood Control Project Maintenance
Levee Inspections**

Maintenance Issue Types Only, Levee Inspection Report By Mile - Fall 2019

Sutter Maintenance Yard East Levee Sutter Bypass

Waterway	Bank	Unit Miles	Inspection Start/End	Inspector
Unit No. 01 Sutter Bypass Levee	Left	21.68	09/25/2019 09/25/2019	Makar Sokol

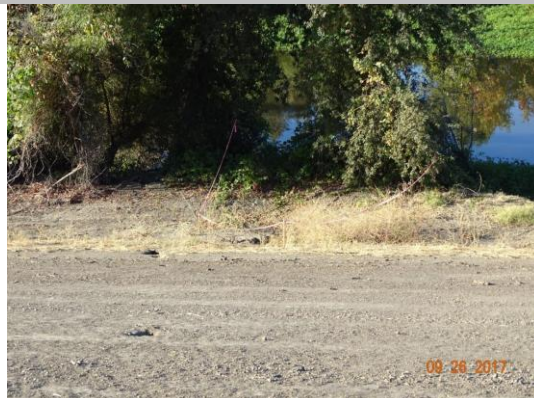
Photo 1 of 1 : FA_2019_ST0002_450_61_20190822_00016.jpg

LM Start	1.61	Rating **	U	Issue No.	61
LM End	1.61	Issue Type +	Ma	Location *	WS
Category	Earthen Levee			GPS Latitude/Longitude	
				Start	End
Item	Erosion / Bank Caving			39.136713 °	39.136713 °
				-121.809202 °	-121.809202 °
DWR ID	DWR_ST0002_01_f_2017_61				
Comment Code					
E2 : Schedule repair of erosion site prior to the next inspection.					
Inspector Comment					
Repair the beaver hole along the waterside berm.

View of the beaver hole along the waterside berm.

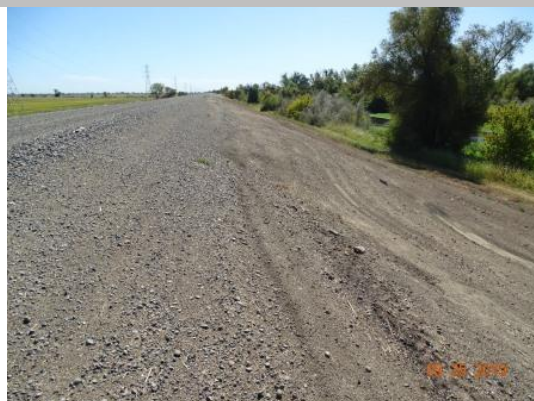
Photo 1 of 1 : FA_2019_ST0002_450_51_20190926_00086.jpg

LM Start	2.32	Rating **	A/W	Issue No.	51
LM End	2.32	Issue Type +	Ma	Location *	WS
Category	Earthen Levee			GPS Latitude/Longitude	
				Start	End
Item	Crown Surface / Depressions / Rutting			39.130704 °	39.130704 °
				-121.798381 °	-121.798381 °
DWR ID	DWR_ST0002_01_f_2019_51				
Comment Code					
C2 : Repair depressions or ruts in the crown or slope.					
Inspector Comment

View of the depression on the waterside slope. Fall 2019.

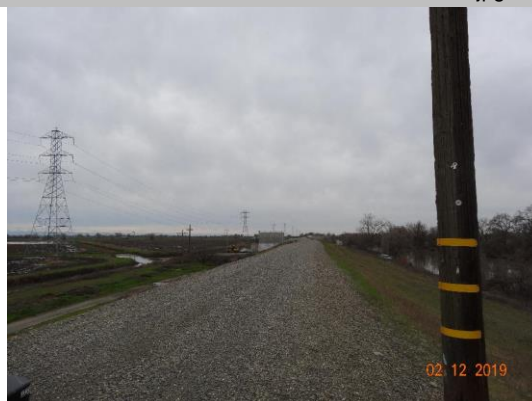
Photo 1 of 3 : UCIP_FA_2019_55218_78856.jpg

DS_ID:16880
FS_ID:55218
EP_NO: N/A
Repair Type: Non-Urgent
Crossing Status: Found
UCIP Comments: 02/12/2019 Record has been updated from No Action Needed to Non-Urgent, no permit has been identified authoring this pump station. Pumping Plant No. 3 is an active plant that has been converted to a gravity drainage system. This structure is operated and maintained by DWR Sutter Yard. No permit is available for this structure. (O. Magana - DWR UCIP)01/11/2019 Record has been updated to show pumping plant is still in use and not abandoned. (O. Magana - DWR UCIP)
04/11/2017 Not abandoned. good condition. (DWR Sutter Yard-AFreitag)10/10/2016 NOT ABANDONED. The old pumping plant was removed but the culverts are still used as a gravity drain to regulate the water level in the LS ditch.(DWR Sutter Yard - aFreitag)04/18/2016 Crossing is in good condition. The culvert is not abandoned and is used as gravity drain for the LS ditch into the bypass channel.05/07/2015 Concrete culverts are still being used as gravity drains for the LS ditch.11/12/2014 Same as last inspection.05/13/2014 Same as last inspection.10/30/2103 Same as last inspection.05/22/2013 Concrete culvert is being used as gravity drain for LS ditch.10/08/2012 Flap gates left in open position. Unable to determine type of abandonment for concrete culverts. Contact inspector to determine type of abandonment.

Overview of levee crown looking towards pumping station.

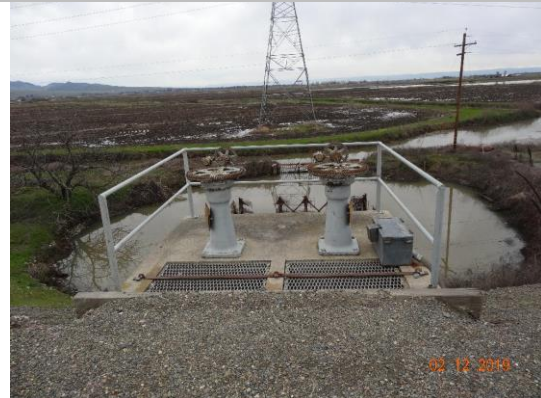
Photo 2 of 3 : UCIP_FA_2019_55218_78857.jpg

DS_ID:16880
FS_ID:55218
EP_NO: N/A
Repair Type: Non-Urgent
Crossing Status: Found
UCIP Comments: 02/12/2019 Record has been updated from No Action Needed to Non-Urgent, no permit has been identified authoring this pump station. Pumping Plant No. 3 is an active plant that has been converted to a gravity drainage system. This structure is operated and maintained by DWR Sutter Yard. No permit is available for this structure. (O. Magana - DWR UCIP)01/11/2019 Record has been updated to show pumping plant is still in use and not abandoned. (O. Magana - DWR UCIP)
04/11/2017 Not abandoned. good condition. (DWR Sutter Yard-AFreitag)10/10/2016 NOT ABANDONED. The old pumping plant was removed but the culverts are still used as a gravity drain to regulate the water level in the LS ditch.(DWR Sutter Yard - aFreitag)04/18/2016 Crossing is in good condition. The culvert is not abandoned and is used as gravity drain for the LS ditch into the bypass channel.05/07/2015 Concrete culverts are still being used as gravity drains for the LS ditch.11/12/2014 Same as last inspection.05/13/2014 Same as last inspection.10/30/2103 Same as last inspection.05/22/2013 Concrete culvert is being used as gravity drain for LS ditch.10/08/2012 Flap gates left in open position. Unable to determine type of abandonment for concrete culverts. Contact inspector to determine type of abandonment.

LS view: slide gate valves located on LS shoulder.

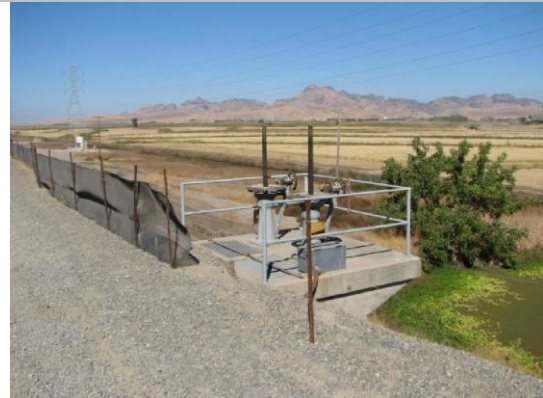
Photo 3 of 3 : UCIP_FA_2019_55218_64815.jpg

DS_ID:16880
FS_ID:55218
EP_NO: N/A
Repair Type: Non-Urgent
Crossing Status: Found
UCIP Comments: 02/12/2019 Record has been updated from No Action Needed to Non-Urgent, no permit has been identified authoring this pump station. Pumping Plant No. 3 is an active plant that has been converted to a gravity drainage system. This structure is operated and maintained by DWR Sutter Yard. No permit is available for this structure. (O. Magana - DWR UCIP)01/11/2019 Record has been updated to show pumping plant is still in use and not abandoned. (O. Magana - DWR UCIP)
04/11/2017 Not abandoned. good condition. (DWR Sutter Yard-AFreitag)10/10/2016 NOT ABANDONED. The old pumping plant was removed but the culverts are still used as a gravity drain to regulate the water level in the LS ditch.(DWR Sutter Yard - aFreitag)04/18/2016 Crossing is in good condition. The culvert is not abandoned and is used as gravity drain for the LS ditch into the bypass channel.05/07/2015 Concrete culverts are still being used as gravity drains for the LS ditch.11/12/2014 Same as last inspection.05/13/2014 Same as last inspection.10/30/2103 Same as last inspection.05/22/2013 Concrete culvert is being used as gravity drain for LS ditch.10/08/2012 Flap gates left in open position. Unable to determine type of abandonment for concrete culverts. Contact inspector to determine type of abandonment.

Slide gates on LS shoulder.

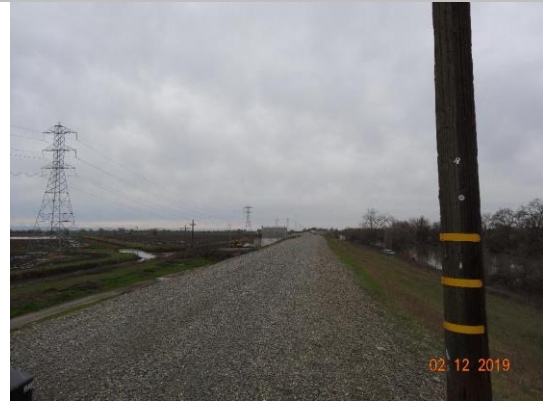
Photo 1 of 3 : UCIP_FA_2019_55219_78863.jpg

Item	DRAFT DWR UCIP LMA Responsibility		39.120358°	39.120358°								
			-121.779775°	-121.779775°								
DWR ID	16895											
Comment Code												
Inspector Comment												
DS_ID:16895 FS_ID:55219 EP_NO: N/A Repair Type: Non-Urgent Crossing Status: Found UCIP Comments: 02/12/2019 Record has been updated from No Action Needed to Non-Urgent, no permit has been identified authoring this pump station. Pumping Plant No. 3 is an active plant that has been converted to a gravity drainage structure. Structure is operated and maintained by DWR Sutter Yard. No permit has been identified for this structure. (O. Magana - DWR UCIP)01/11/2019 Record has been updated to show pumping plant is still in use and not abandoned. (O. Magana - DWR UCIP) 04/11/2017 Not abandoned. Good condition. (DWR Sutter Yard-AFreitag)10/10/2016 NOT ABANDONED. The old pumping plant was removed but the culverts are still used as a gravity drain to regulate the water level in the LS ditch. (DWR Sutter Yard - afreitag)04/18/2016 Crossing is in good condition. The culvert is not abandoned and is used as gravity drain for the LS ditch into the bypass channel.05/07/2015 Concrete culverts still being used as gravity drains for LS ditch.11/12/2014 Same as last inspection.05/13/2014 Same as last inspection.10/30/2103 Same as last inspection.05/22/2013 Concrete culvert is being used as gravity drain for LS ditch.10/08/2012 Flap gates in open position. Need to determine type of abandonment. Contact inspector to determine abandonment. FIELD_STRUCT_DESC: [Pumping Plant No. 3] 2 of 2: 48-inch by 72-inch reinforced concrete drainage culvert through the levee, 30 feet below the crown. Slide gate in concrete well on the landside (LS) shoulder. Wood flap gate and concrete headwall on the waterside (WS) end. Abandoned State pumping plant on the LS. [Additional Reference(s): DWR Levee Log, 2005. USACE Sacramento O&M Manual 315, May 1953 (Station 966+30)]. FS Date: 2/12/2019 3:06:00 PM

Overview of levee crown looking towards pumping station.

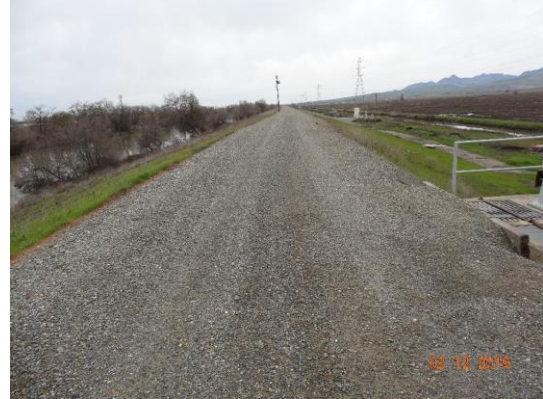
Photo 2 of 3 : UCIP_FA_2019_55219_78866.jpg

Comment Code						
Inspector Comment						
DS_ID:16895 FS_ID:55219 EP_NO: N/A Repair Type: Non-Urgent Crossing Status: Found UCIP Comments: 02/12/2019 Record has been updated from No Action Needed to Non-Urgent, no permit has been identified authoring this pump station. Pumping Plant No. 3 is an active plant that has been converted to a gravity drainage structure. Structure is operated and maintained by DWR Sutter Yard. No permit has been identified for this structure. (O. Magana - DWR UCIP)01/11/2019 Record has been updated to show pumping plant is still in use and not abandoned. (O. Magana - DWR UCIP) 04/11/2017 Not abandoned. Good condition. (DWR Sutter Yard-AFreitag)10/10/2016 NOT ABANDONED. The old pumping plant was removed but the culverts are still used as a gravity drain to regulate the water level in the LS ditch. (DWR Sutter Yard - aFreitag)04/18/2016 Crossing is in good condition. The culvert is not abandoned and is used as gravity drain for the LS ditch into the bypass channel.05/07/2015 Concrete culverts still being used as gravity drains for LS ditch.11/12/2014 Same as last inspection.05/13/2014 Same as last inspection.10/30/2103 Same as last inspection.05/22/2013 Concrete culvert is being used as gravity drain for LS ditch.10/08/2012 Flap gates in open position. Need to determine type of abandonment. Contact inspector to determine abandonment. FIELD_STRUCT_DESC: [Pumping Plant No. 3] 2 of 2: 48-inch by 72-inch reinforced concrete drainage culvert through the levee, 30 feet below the crown. Slide gate in concrete well on the landside (LS) shoulder. Wood flap gate and concrete headwall on the waterside (WS) end. Abandoned State pumping plant on the LS. [Additional Reference(s): DWR Levee Log, 2005. USACE Sacramento O&M Manual 315, May 1953 (Station 966+30)]. FS Date: 2/12/2019 3:06:00 PM

Overview of levee crown, photo taken at crossings looking u/s.

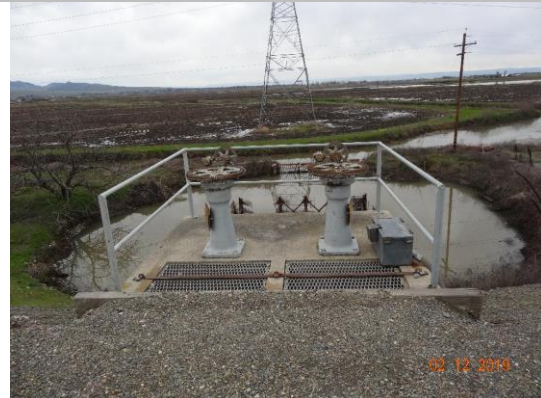
Photo 3 of 3 : UCIP_FA_2019_55219_78864.jpg

DS_ID:16895
FS_ID:55219
EP_NO: N/A
Repair Type: Non-Urgent
Crossing Status: Found
UCIP Comments: 02/12/2019 Record has been updated from No Action Needed to Non-Urgent, no permit has been identified authoring this pump station. Pumping Plant No. 3 is an active plant that has been converted to a gravity drainage structure. Structure is operated and maintained by DWR Sutter Yard. No permit has been identified for this structure. (O. Magana - DWR UCIP)01/11/2019 Record has been updated to show pumping plant is still in use and not abandoned. (O. Magana - DWR UCIP)
04/11/2017 Not abandoned. Good condition. (DWR Sutter Yard-AFreitag)10/10/2016 NOT ABANDONED. The old pumping plant was removed but the culverts are still used as a gravity drain to regulate the water level in the LS ditch. (DWR Sutter Yard - aFreitag)04/18/2016 Crossing is in good condition. The culvert is not abandoned and is used as gravity drain for the LS ditch into the bypass channel.05/07/2015 Concrete culverts still being used as gravity drains for LS ditch.11/12/2014 Same as last inspection.05/13/2014 Same as last inspection.10/30/2103 Same as last inspection.05/22/2013 Concrete culvert is being used as gravity drain for LS ditch.10/08/2012 Flap gates in open position. Need to determine type of abandonment. Contact inspector to determine abandonment.

LS view: slide gate valves located on LS shoulder.

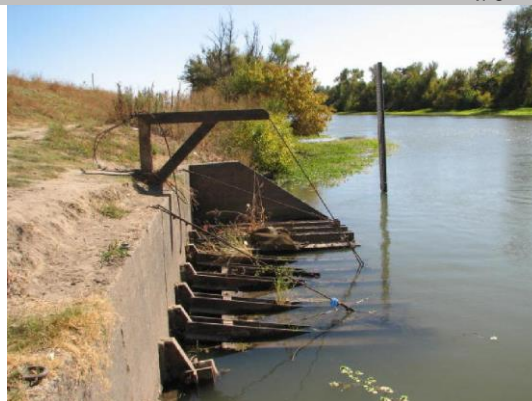
Photo 2 of 3 : UCIP_FA_2019_55258_65250.jpg

Flap gates on WS toe.

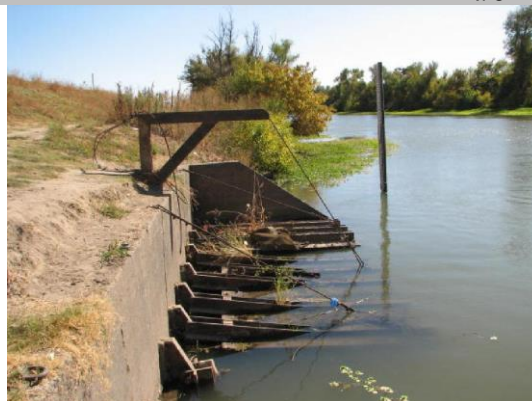
Photo 2 of 3 : UCIP_FA_2019_55257_65253.jpg

Flap gates on WS toe.

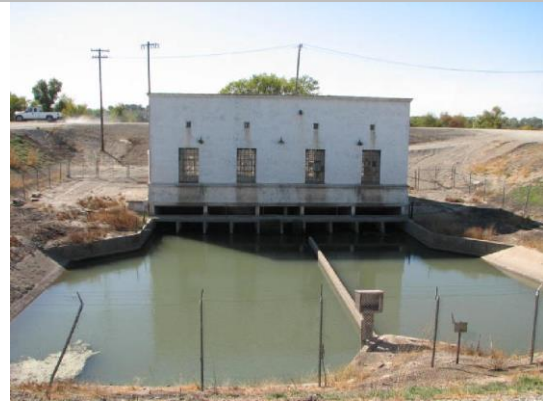
Photo 3 of 3 : UCIP_FA_2019_55257_65252.jpg

Comment Code						
Inspector Comment						
DS_ID:16906 FS_ID:55257 EP_NO: N/A Repair Type: Non-Urgent Crossing Status: Found UCIP Comments: 05/01/2019 Record remains Non-Urgent, no permit has been identified authorizing pump station. Crossing 2 of 5 is abandoned. Need to determine how pipe was abandoned. This pump station is used as a gravity drainage structure, pumps have been removed from this structure. (O. Magana - DWR UCIP)04/11/2017 Abandoned.10/10/2016 Crossing appears to be in good condition. (DWR Sutter Yard - afreitag)04/18/2016 Abandoned crossing but no noticeable issues seen with it.05/07/2015 Abandoned crossing but no noticeable issues to report.11/12/2014 Same as last inspection.05/13/2014 Same as last inspection.10/30/2013 Same as last inspection.05/22/2013 Same as last inspection.10/08/2012 Determine type of abandonment. FIELD_STRUCT_DESC: *ABANDONED* [Pumping Plant No. 2] 2 of 5: 48-inch by 72-inch reinforced concrete drainage culvert through the levee, 31.5 feet below the crown. Wood flap gate and concrete headwall on the waterside (WS) end. Wooden steps on the landside (LS) slope. Concrete steps on the WS end. [Additional Reference(s): DWR Levee Log, 2005. USACE Sacramento O&M Manual 315, May 1953 (Station 582+19)]. FS Date: 5/1/2019 2:30:00 PM

Pumping plant on LS toe.

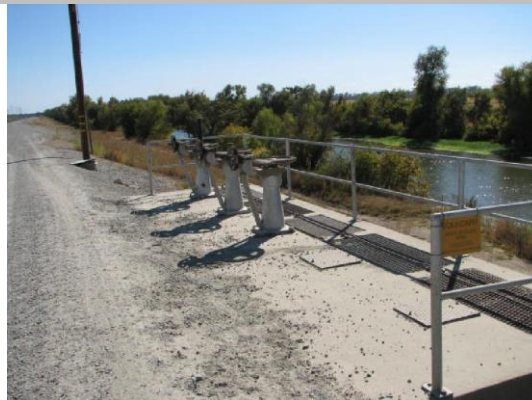
Photo 1 of 3 : UCIP_FA_2019_55254_65257.jpg

DS_ID:16907
FS_ID:55254
EP_NO: N/A
Repair Type: Non-Urgent
Crossing Status: Found
UCIP Comments: 05/01/2019 Record has been updated from No Action Needed to Non-Urgent, no permit has been identified authorizing pump station. This pump station is used as a gravity drainage structure, pumps have been removed from this structure. (O. Magana - DWR UCIP)04/11/2017 Not abandoned. Good condition. (DWR Sutter Yard- A Freitag)10/10/2016 NOT ABANDONED. The old pumping plant was removed but the culverts are still used as a gravity drain to regulate the water level in the LS ditch.(DWR Sutter Yard - a Freitag)04/18/2016 Crossing is in good condition. The culvert is not abandoned and is used as gravity drain for the LS ditch into the bypass channel.05/07/2015 Concrete culvert is being used as a gravity drain for LS ditch.11/12/2014 Same as last inspection.05/13/2014 Same as last inspection.10/30/2013 Same as last inspection.05/22/2013 Concrete culvert is being used as gravity drain for LS ditch.10/08/2012 Need to determine type of abandonment.

Slide gates on WS shoulder.

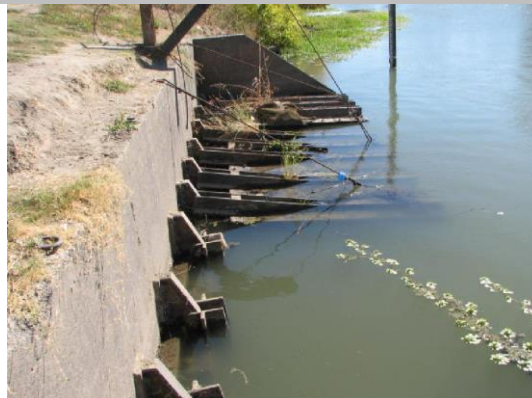
Photo 2 of 3 : UCIP_FA_2019_55254_65256.jpg

DS_ID:16907
FS_ID:55254
EP_NO: N/A
Repair Type: Non-Urgent
Crossing Status: Found
UCIP Comments: 05/01/2019 Record has been updated from No Action Needed to Non-Urgent, no permit has been identified authorizing pump station. This pump station is used as a gravity drainage structure, pumps have been removed from this structure. (O. Magana - DWR UCIP)04/11/2017 Not abandoned. Good condition. (DWR Sutter Yard- A Freitag)10/10/2016 NOT ABANDONED. The old pumping plant was removed but the culverts are still used as a gravity drain to regulate the water level in the LS ditch.(DWR Sutter Yard - a Freitag)04/18/2016 Crossing is in good condition. The culvert is not abandoned and is used as gravity drain for the LS ditch into the bypass channel.05/07/2015 Concrete culvert is being used as a gravity drain for LS ditch.11/12/2014 Same as last inspection.05/13/2014 Same as last inspection.10/30/2013 Same as last inspection.05/22/2013 Concrete culvert is being used as gravity drain for LS ditch.10/08/2012 Need to determine type of abandonment.

Flap gates on WS toe.

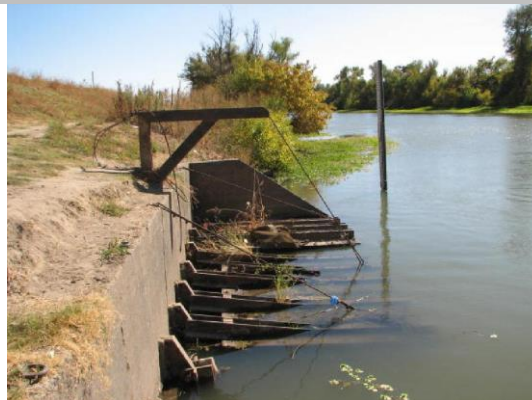
Photo 2 of 3 : UCIP_FA_2019_55255_65259.jpg

DS_ID:16908
FS_ID:55255
EP_NO: N/A
Repair Type: Non-Urgent
Crossing Status: Found
UCIP Comments: 05/01/2019 Record has been updated from No Action Needed to Non-Urgent, no permit has been identified authorizing pump station. This pump station is used as a gravity drainage structure, pumps have been removed from this structure. (O. Magana - DWR UCIP)04/11/2017 Not abandoned. Good condition. (DWR Sutter Yard- A Freitag)10/10/2016 NOT ABANDONED. The old pumping plant was removed but the culverts are still used as a gravity drain to regulate the water level in the LS ditch.(DWR Sutter Yard - Freitag)04/18/2016 Crossing is in good condition. The culvert is not abandoned and is used as gravity drain for the LS ditch into the bypass channel.05/07/2015 Concrete culvert is being used as a gravity drain for LS ditch.11/12/2014 Same as last inspection.10/30/2013 Same as last inspection.10/08/2012 Need to determine type of abandonment.05/22/2013 Concrete culvert is being used as gravity drain for LS ditch.

Flap gates on WS toe.

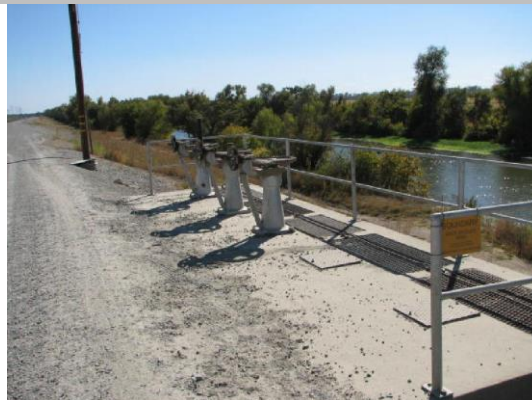
Photo 1 of 3 : UCIP_FA_2019_55256_65263.jpg

Comment Code						
Inspector Comment						
DS_ID:16909 FS_ID:55256 EP_NO: N/A Repair Type: Non-Urgent Crossing Status: Found UCIP Comments: 05/01/2019 Record has been updated from No Action Needed to Non-Urgent, no permit has been identified authorizing pump station. This pump station is used as a gravity drainage structure, pumps have been removed from this structure. (O. Magana - DWR UCIP)04/11/2017 Not abandoned. Good condition. (DWR Sutter Yard- A Freitag)10/10/2016 NOT ABANDONED. The old pumping plant was removed but the culverts are still used as a gravity drain to regulate the water level in the LS ditch.(DWR Sutter Yard - a Freitag)04/18/2016 Crossing is in good condition. The culvert is not abandoned and is used as gravity drain for the LS ditch into the bypass channel.05/07/2015 Concrete culvert is being used as a gravity drain for LS ditch.11/12/2014 Same as last inspection.05/13/2014 Same as last inspection.10/30/2013 Same as last inspection.05/22/2013 Concrete culvert is being used as gravity drain for LS ditch.10/08/2012 Need to determine type of abandonment for pipe. FIELD_STRUCT_DESC: [Pumping Plant No. 2] 5 of 5: 48-inch by 72-inch reinforced concrete drainage culvert through the levee, 31.5 feet below the crown. Slide gate in concrete well on the waterside (WS) shoulder. Wood flap gate and concrete headwall on the WS end. Wooden steps on the landside (LS) slope. Concrete steps on the WS end. [Additional Reference(s): DWR Levee Log, 2005. USACE Sacramento O&M Manual 315, May 1953 (Station 582+19)]. FS Date: 5/1/2019 3:13:00 PM

Slide gates on WS shoulder.

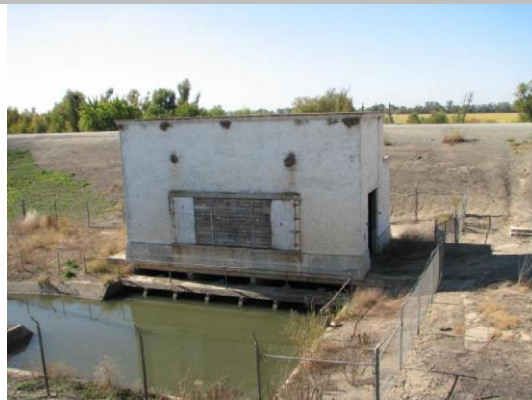
Photo 1 of 3 : UCIP_FA_2019_55285_65326.jpg

DS_ID:16877
FS_ID:55285
EP_NO: N/A
Repair Type: Non-Urgent
Crossing Status: Found
UCIP Comments: 05/01/2019 Record has been updated from No Action Needed to Non-Urgent, no permit has been identified authorizing pump station. As noted back in 2016 by A. Freitag, this pumping plant has been modified to be used as a gravity drain to regulate the water levee in the LS ditch. This pumping station is maintained by DWR Sutter Yard. (O. Magana - DWR UCIP)04/11/2017 Not abandoned. Good condition. (DWR Sutter Yard - A.Freitag)10/10/2016 NOT ABANDONED. The old pumping plant was abandoned but the culverts are still used as a gravity drain to regulate the water level in the LS ditch.(DWR Sutter Yard - a.freitag)04/18/2016 Crossing is in good condition. The culvert is not abandoned and is used as gravity drain for the LS ditch into the bypass channel.05/07/2015 Concrete culvert is being used as a gravity drain for LS ditch.11/12/2014 Same as last inspection.05/14/2014 Same as last inspection.10/30/2013 Same as last inspection.05/23/2013 Concrete culvert is being used as gravity drain for LS ditch.10/09/2012 Determine type of abandonment for concrete culvert.

Pumphouse on LS toe.

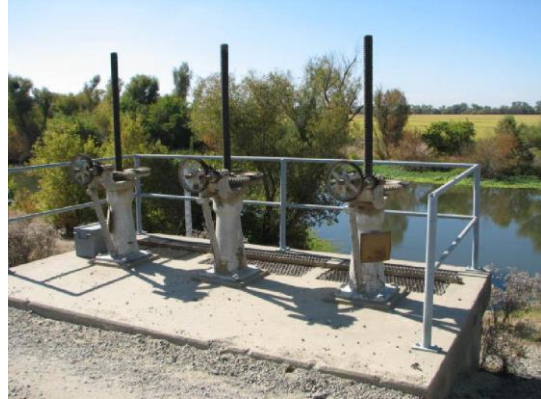
Photo 2 of 3 : UCIP_FA_2019_55285_65325.jpg

Comment Code						
Inspector Comment						
DS_ID:16877 FS_ID:55285 EP_NO: N/A Repair Type: Non-Urgent Crossing Status: Found UCIP Comments: 05/01/2019 Record has been updated from No Action Needed to Non-Urgent, no permit has been identified authorizing pump station. As noted back in 2016 by A. Freitag, this pumping plant has been modified to be used as a gravity drain to regulate the water levee in the LS ditch. This pumping station is maintained by DWR Sutter Yard. (O. Magana - DWR UCIP)04/11/2017 Not abandoned. Good condition. (DWR Sutter Yard - AFreitag)10/10/2016 NOT ABANDONED. The old pumping plant was abandoned but the culverts are still used as a gravity drain to regulate the water level in the LS ditch.(DWR Sutter Yard - aFreitag)04/18/2016 Crossing is in good condition. The culvert is not abandoned and is used as gravity drain for the LS ditch into the bypass channel.05/07/2015 Concrete culvert is being used as a gravity drain for LS ditch.11/12/2014 Same as last inspection.05/14/2014 Same as last inspection.10/30/2013 Same as last inspection.05/23/2013 Concrete culvert is being used as gravity drain for LS ditch.10/09/2012 Determine type of abandonment for concrete culvert. FIELD_STRUCT_DESC: [Pumping Plant No. 1] 1 of 3: 48-inch by 72-inch reinforced concrete drainage culvert through the levee, 26 feet below the crown. Slide gates in a concrete well on the waterside (WS) shoulder. Wooden flap gates and concrete headwall on the WS end. Concrete steps and staff gage reading to 53 feet on the WS slope. [Additional Reference(s): DWR Levee Log, 2005. USACE Sacramento O&M Manual 315, May 1953 (Station 141+46)]. FS Date: 5/1/2019 2:41:00 PM

Slide gates on WS shoulder.

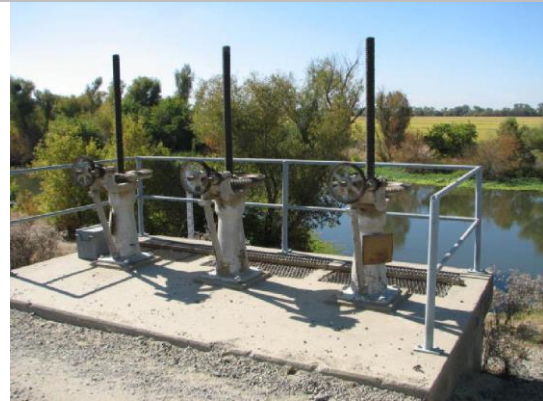
Photo 2 of 3 : UCIP_FA_2019_55286_65329.jpg

Comment Code						
Inspector Comment						
DS_ID:17027 FS_ID:55286 EP_NO: N/A Repair Type: Non-Urgent Crossing Status: Found UCIP Comments: 05/01/2019 Record has been updated from No Action Needed to Non-Urgent, no permit has been identified authorizing pump station. As noted back in 2016 by A. Freitag, this pumping plant has been modified to be used as a gravity drain to regulate the water levee in the LS ditch. This pumping station is maintained by DWR Sutter Yard. (O. Magana - DWR UCIP)04/11/2017 Not abandoned. Good Condition. (DWR Sutter Yard- AFreitag)10/10/2016 NOT ABANDONED. The old pumping plant was abandoned but the culverts are still used as a gravity drain to regulate the water level in the LS ditch.(DWR Sutter Yard - aFreitag)04/18/2016 Crossing is in good condition. The culvert is not abandoned and is used as gravity drain for the LS ditch into the bypass channel.05/07/2015 Concrete culvert is being used as a gravity drain for LS ditch.11/12/2014 Same as last inspection.05/14/2014 Same as last inspection.10/30/2013 Same as last inspection.05/23/2013 Concrete culvert is being used as gravity drain for LS ditch.10/09/2012 Determine type of abandonment for concrete culverts. FIELD_STRUCT_DESC: [Pumping Plant No. 1] 2 of 3: 48-inch by 72-inch reinforced concrete drainage culvert through the levee, 26 feet below the crown. Slide gates in a concrete well on the waterside (WS) shoulder. Wooden flap gates and concrete headwall on the WS end. Concrete steps and staff gage reading to 53 feet on the WS slope. [Additional Reference(s): DWR Levee Log, 2005. USACE Sacramento O&M Manual 315, May 1953 (Station 141+46)]. FS Date: 5/1/2019 2:42:00 PM

Slide gates on WS shoulder.
